Manhole Inspection Summary

Manhole # S21GG_009MH

Location Address: **1612 FULTON AVE**

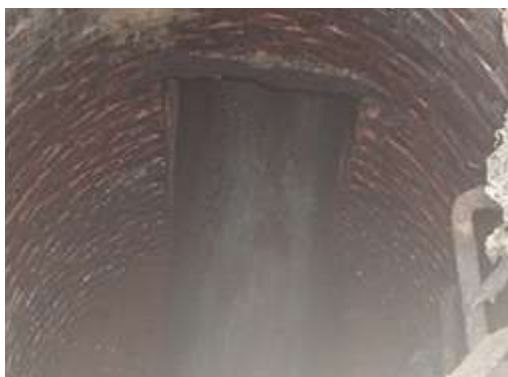
Comments **I6 IS DROPPING OFF ABOUT 3 FT FROM PIPE LIKE A WATER FALL, COMING THROUGH A HUGE RECTANGLE OPENING**

RECTANGLE OPENING AT I6

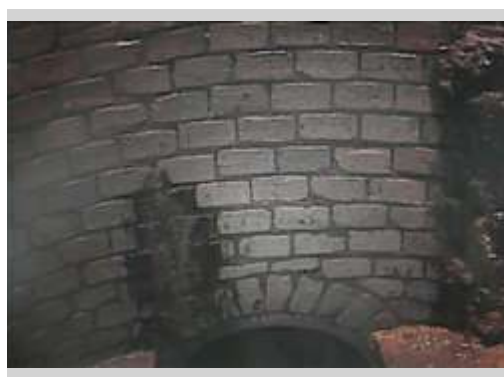
Defect 5

CHANNEL OF THE I6

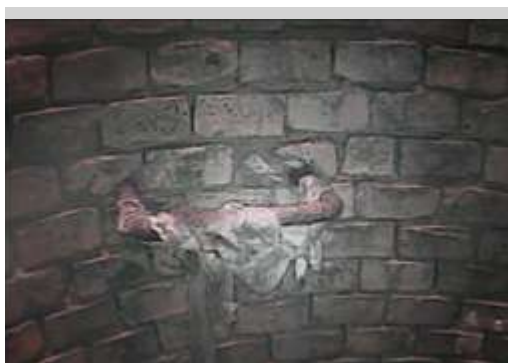
Defect 4

Infiltration: ☐ None ☐ Joint ☐ Cracks ☐ Mortar ☐ Roots ☒ **Wall**

INFILTRATION OF BARREL

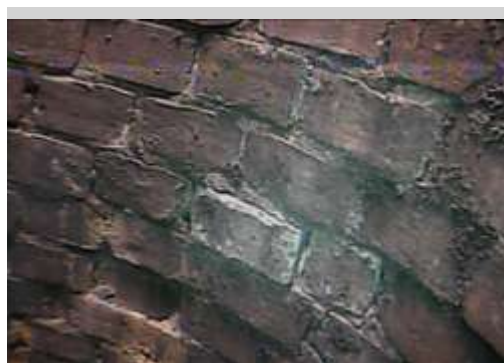
Defect 3

Surcharge ☒ **Evidence Of Surcharge** Depth: **8** (ft.) ☐ Active Surcharge Present

SURCHARGE EVIDENCE ON STEPS

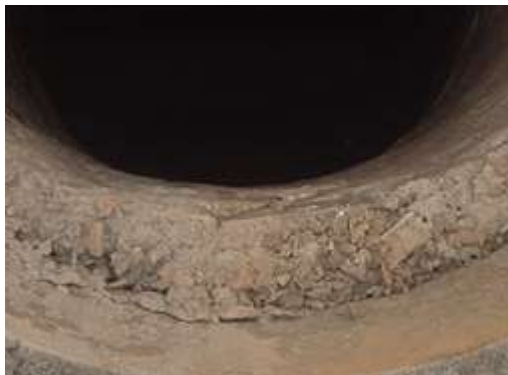
Defect 2

Condition: ☐ Sound ☐ Cracked ☐ Root Intrusion ☒ **Loose Brick** ☐ Deteriorated

LOOSE CORBEL BRICKS

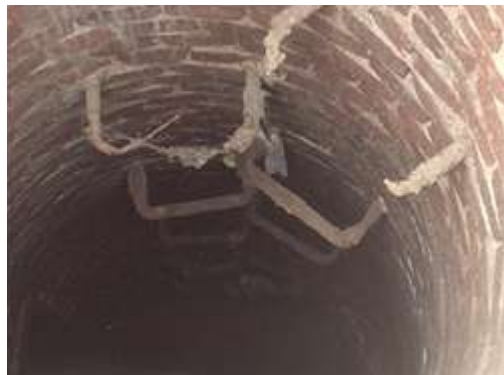
Defect 1

Frame Offset: **2** (in.) Condition: ☒ Sound ☐ Cracked ☐ Leaks

FRAME OFFSET

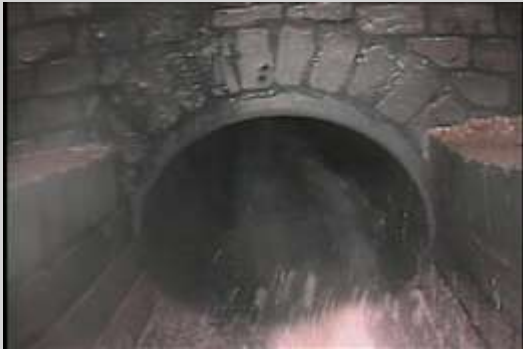
Steps Count: **9** Missing: **2** ☒ **Corroded**

CORRODED AND MISSING STEPS
